Convention Paper 7909

The 48 Volt Phantom Menace Returns

Rosalfonso Bortoni¹ and Wayne Kirkwood²

THAT Corporation, Milford, MA, 01757, USA
rb@thatcorp.com and wek@thatcorp.com

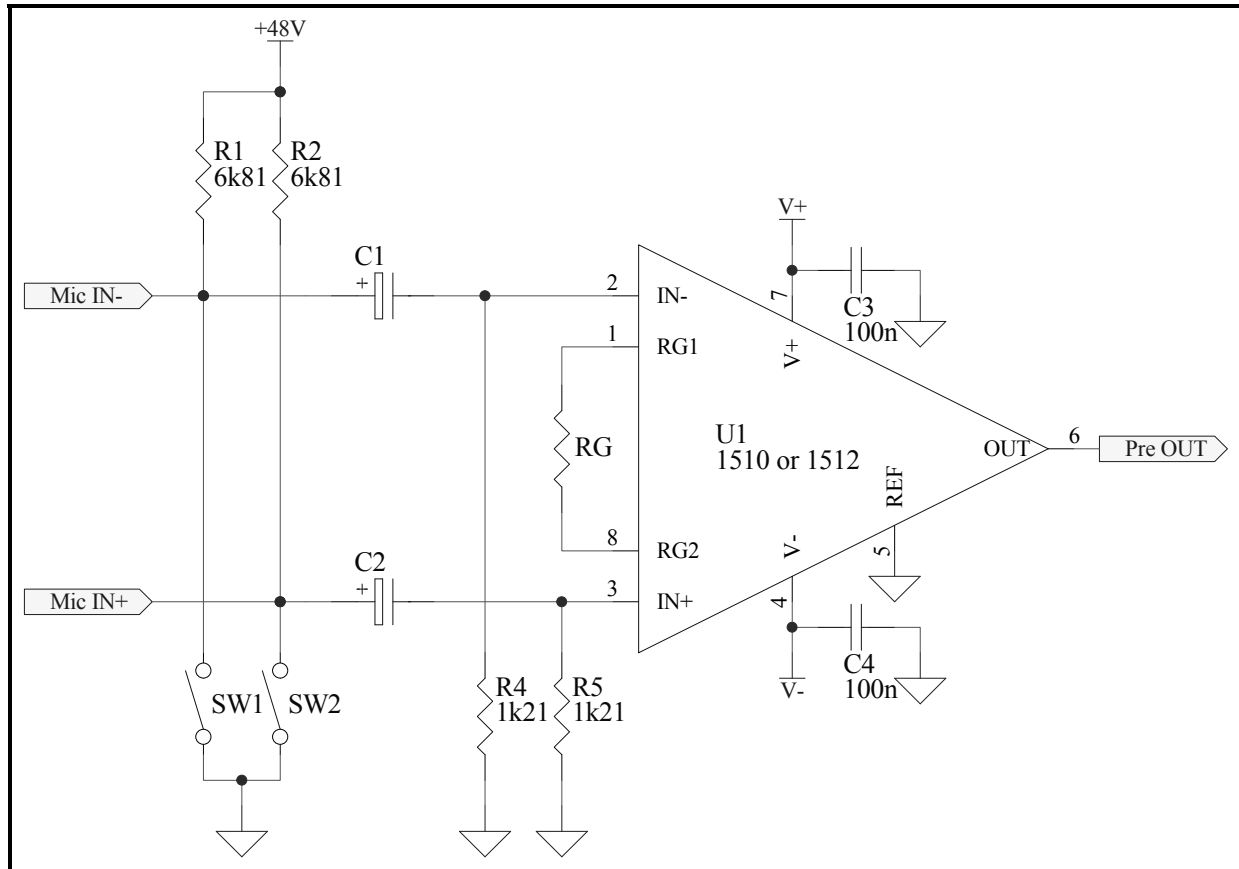
Figure 1 shows, from the perspective of phantom power faults, an unprotected microphone preamplifier using the THAT 1510/1512 with phantom power capability. Phantom power faults are simulated by closing switches SW1 and/or SW2.

Figure 1. Microphone preamplifier with phantom power capability. Switches SW1 and SW2, when properly closed, cause the three fault modes discussed in this paper.

In normal operation, both SW1 and SW2 are open and the differential microphone signal is connected between the junction of R1 and C1, and the junction of R2 and C2. Closing both switches simultaneously simulates the common-mode fault described by Hebert and Thomas. Closing one (or the other) individually while the other switch remains open simulates the “single-ended” fault. Closing the first switch, then the second switch (while the first one remains closed) simulates a “differential” fault.

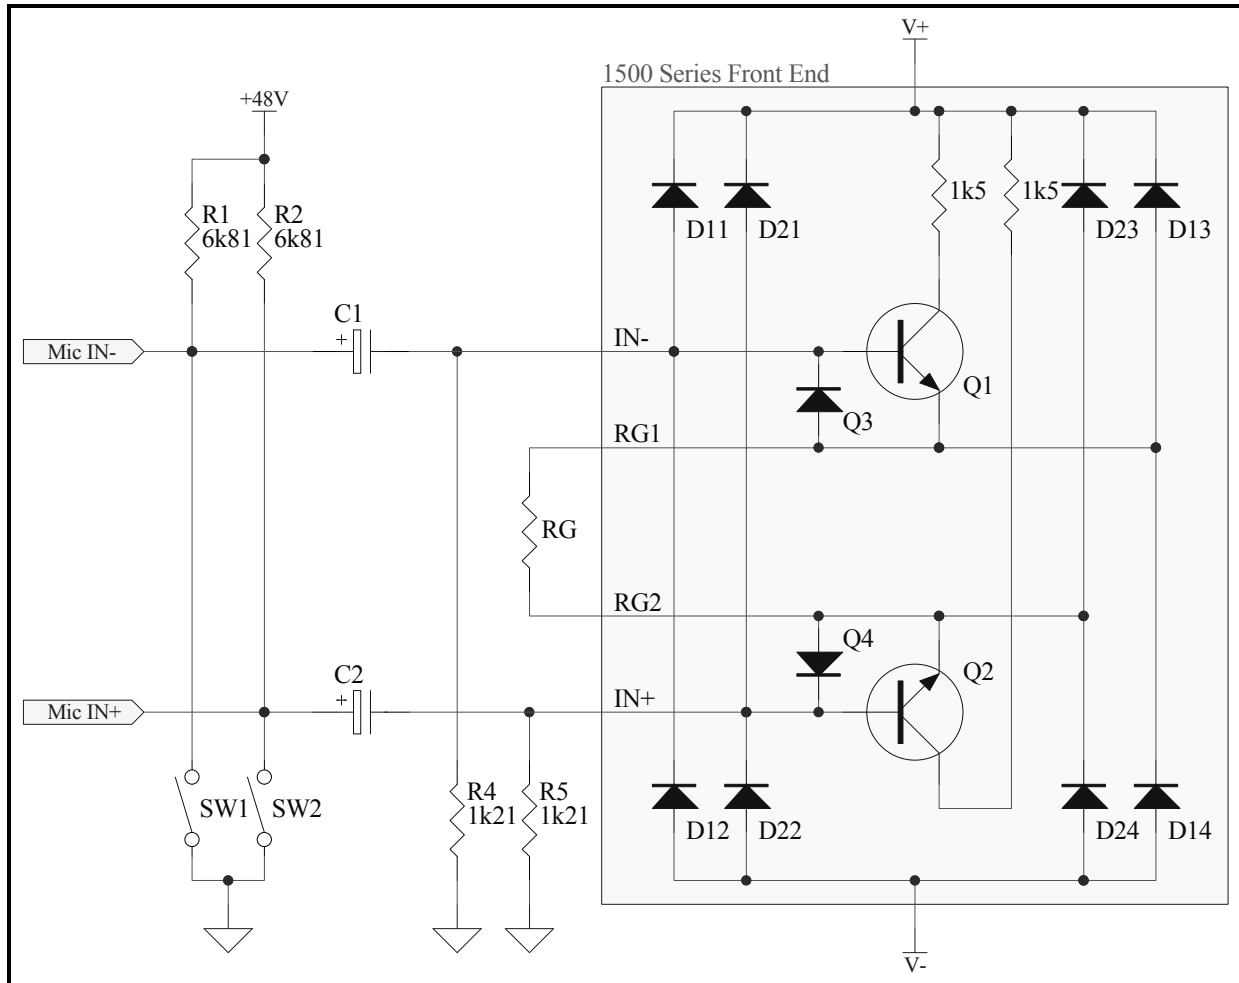
This circuit includes a THAT 1500-series simplified front end circuit with external gain and bias resistors (RG, R4, and R5, respectively), input coupling

capacitors (C1 and C2), and phantom power connections (+48 V and 6.81 k Ω resistors R1 and R2).

The 1500-series’ front end is represented by the input transistors Q1 and Q2, their respective base-emitter reverse-bias protection diodes Q3 and Q4, and internal (ESD protection) diodes D11, D12, D13, D14, D21, D22, D23, and D24 [2].

Figure 2. Microphone preamplifier basic input circuit used for simulations.

Our analysis was intended to determine the voltages and current paths that appear during each of the fault modes under discussion, as well as the magnitudes of the transient signals. The basic circuit used for simulations is shown in Figure 2.

Simulations of current and voltages flowing in this circuit were made for all three variations of fault conditions, with five different values of input capacitors (C1 and C2). The input capacitors simulated include three commonly used values: 22 μ F, 47 μ F, and 100 μ F, and two other less-common values: 220 μ F and 470 μ F. As might be expected, the duration of the fault currents is much longer with larger input coupling capacitors. The larger capacitors require more energy to be dissipated in the circuit and its protection network [1].

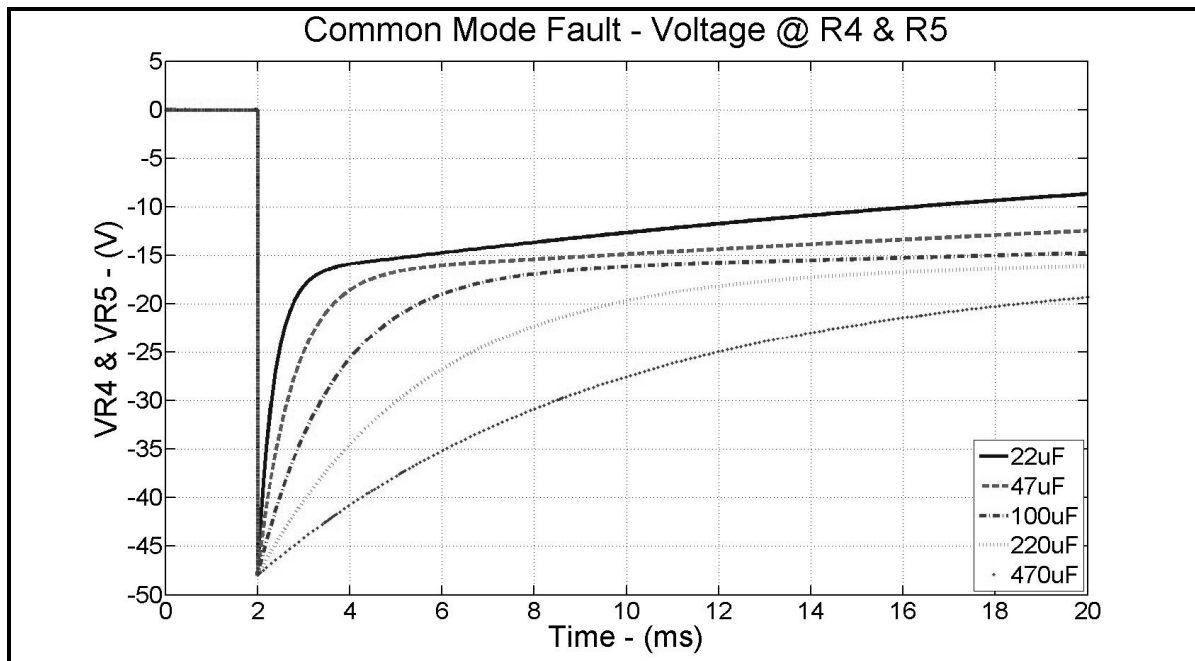
Figure 3 shows an idealized (SPICE) simulation of this voltage vs. time (the fault occurs at $t=2\text{ms}$). This simulation assumes that the supply rails (V+ and V-) for the IC are ± 15 V. The time it takes for C1 and C2 to discharge is proportional to their value. The simulation shows that after closing SW1 and SW2, the charge on the input capacitors first finds a discharge path to the V- rail through several paths internal to the IC (see Figure 4). The most direct is through electro-static discharge (ESD) protection diodes D12 and D22. Note that it reaches a peak of ~ 1.2 Amperes; the duration of the current spike depends on the size of the input coupling capacitors.

Figure 3. Voltage across bias resistors R4 and R5 during the common mode fault, circuit of Figure 2.

accounts for the second, longer time constant evident in the 22 μF cap curve of Figure 3. There is one exponential discharge to the -15 V rail, based on the time constant formed by the protection diodes and the input coupling capacitors, and then a second to ground based on the time constant formed by the input bias resistors and the input coupling capacitors.

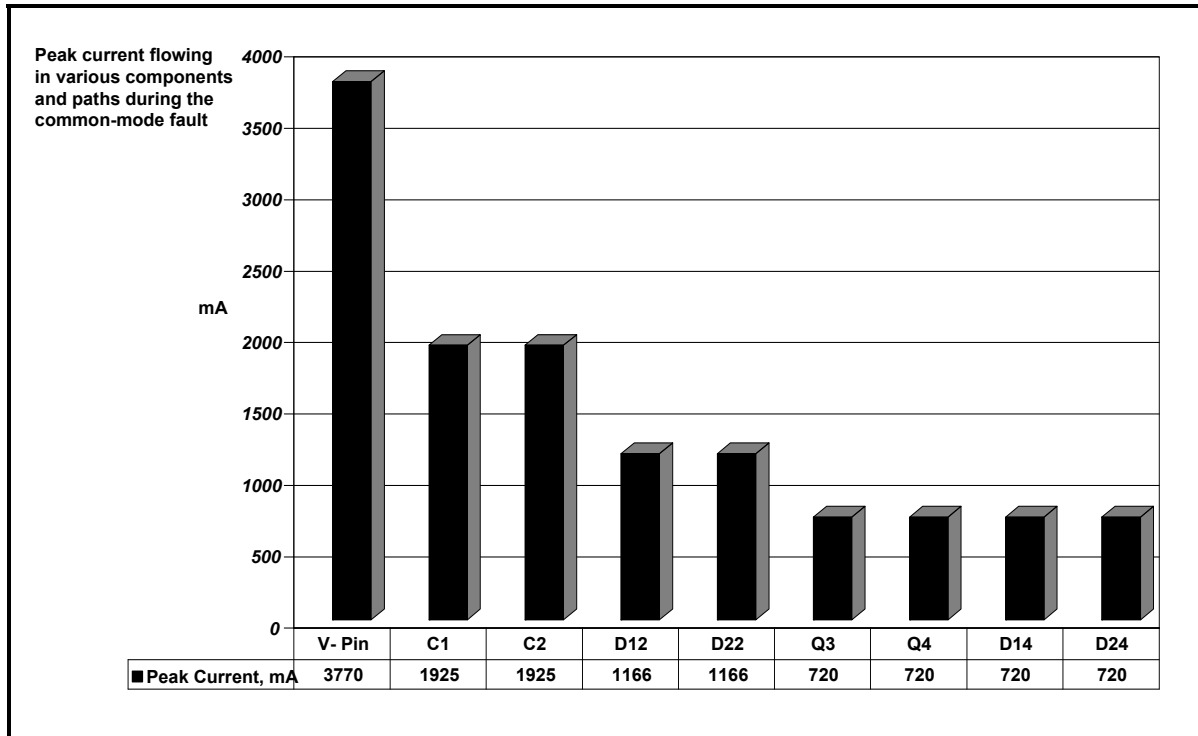
Figure 4. Current distribution during the common mode fault.

Referring to Figure 5, the currents through the input capacitors C1 and C2 end up flowing into the V- pin of the IC. As shown in Figure 4, each input capacitor delivers currents up to nearly 2 *Ampères*; the total current flowing through the negative power supply pin in the IC is almost 4 A!

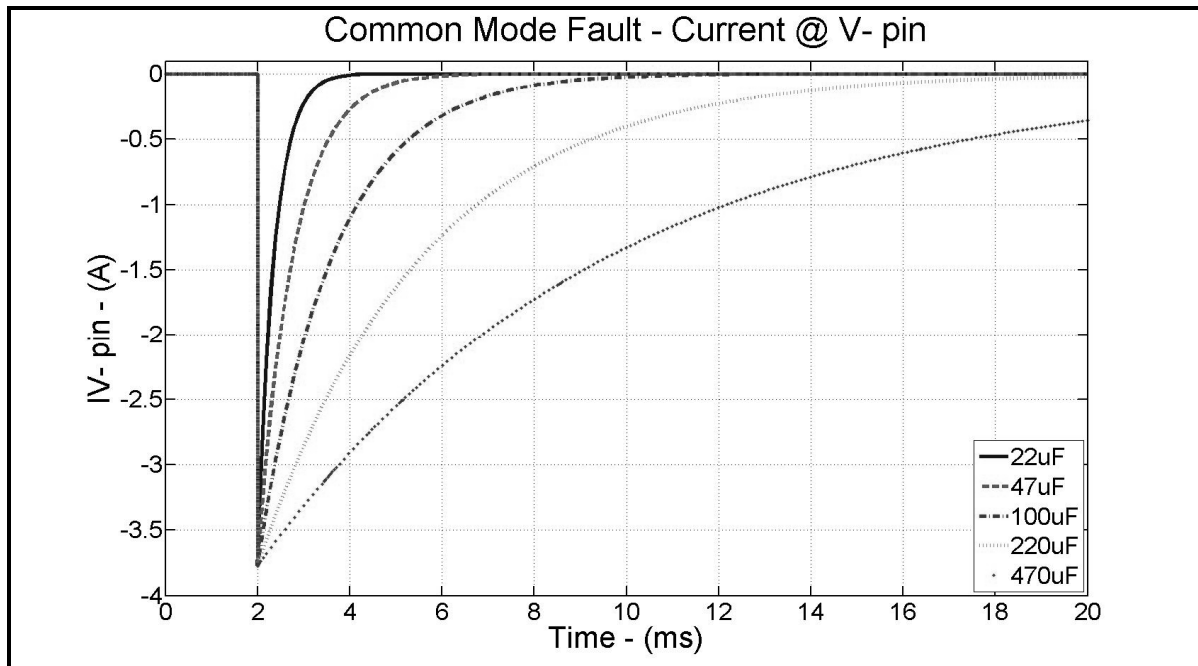
Figure 5. Total fault current flowing through the IC (at V- pin).

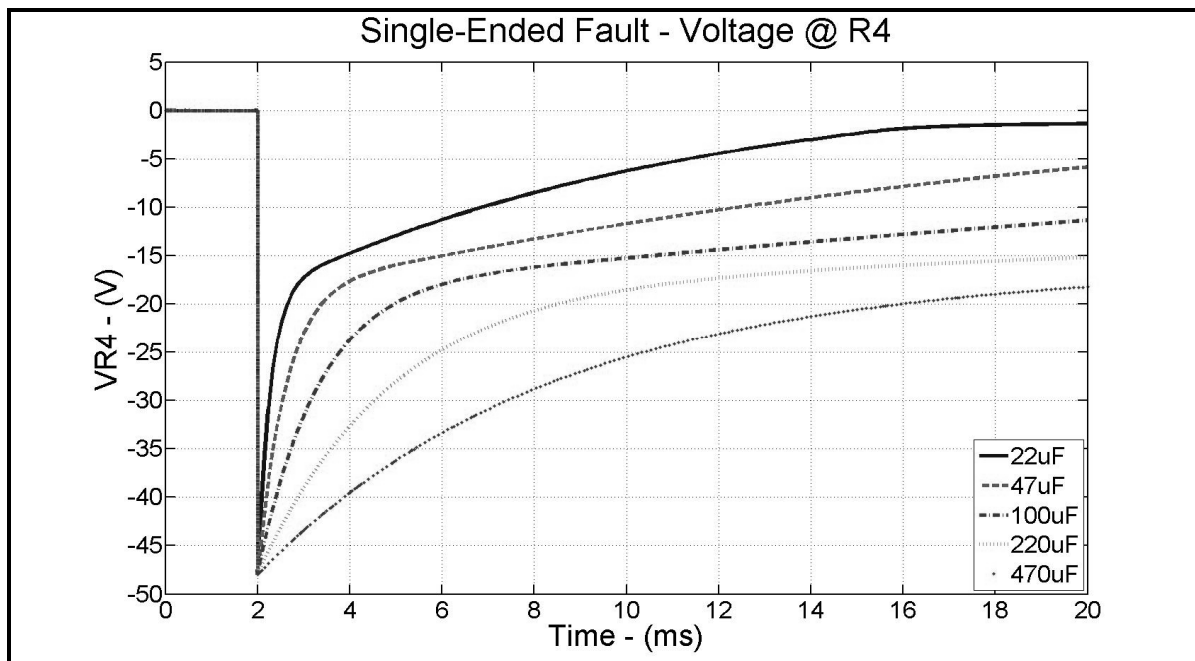
When SW1 is closed, -48 V appears instantaneously across bias resistor R4, as shown in Figure 6. As in the common-mode fault, input capacitor C1 discharges to the V- rail primarily through protection diode D12, but also through Q3 in series with D14. Additionally, in this mode, since the IN- pin initially remains near -48 V, current flows through Q3 in series with RG and D24, and through Q3 in series with RG, the base-emitter junction of Q2, and D22. For simplicity, we only describe the case in which C1 is connected to ground. The results are symmetrical if, instead, C2 is connected to ground. Once the IN- pin reaches the negative supply rail (assumed to be -15 V in the simulation), fault currents stop flowing through the IC and the remaining charge on C1 bleeds off through R4. As

Figure 6. Voltage across bias resistor R4.

in the common-mode fault, this gives rise to the two time constants evident in Figure 6.

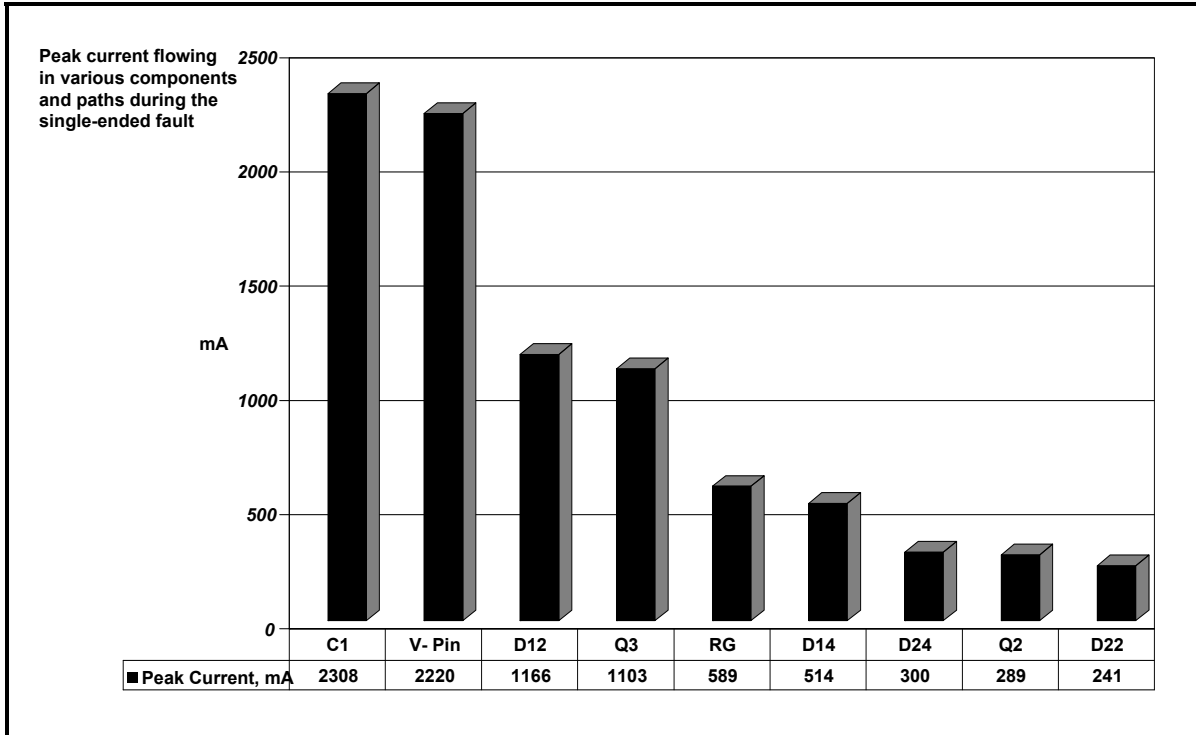
Figure 7 shows the levels of these currents. In the single-ended fault, the simulation predicts that the input capacitor will deliver a peak current of almost 2.4 A, almost all of which flows through the IC's negative supply pin (see Figures 7 and 8). Individual components within the IC are exposed to significant currents.

Figure 7. Current distribution during the single-ended fault.

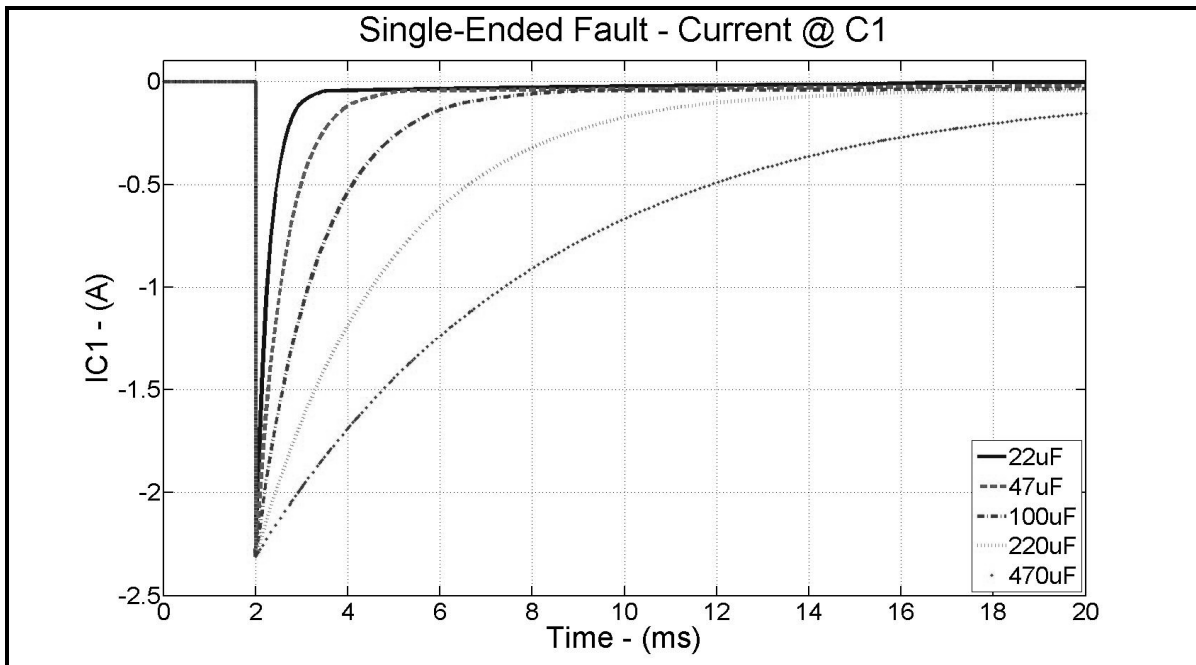
Figure 8. Current through input capacitor C1.

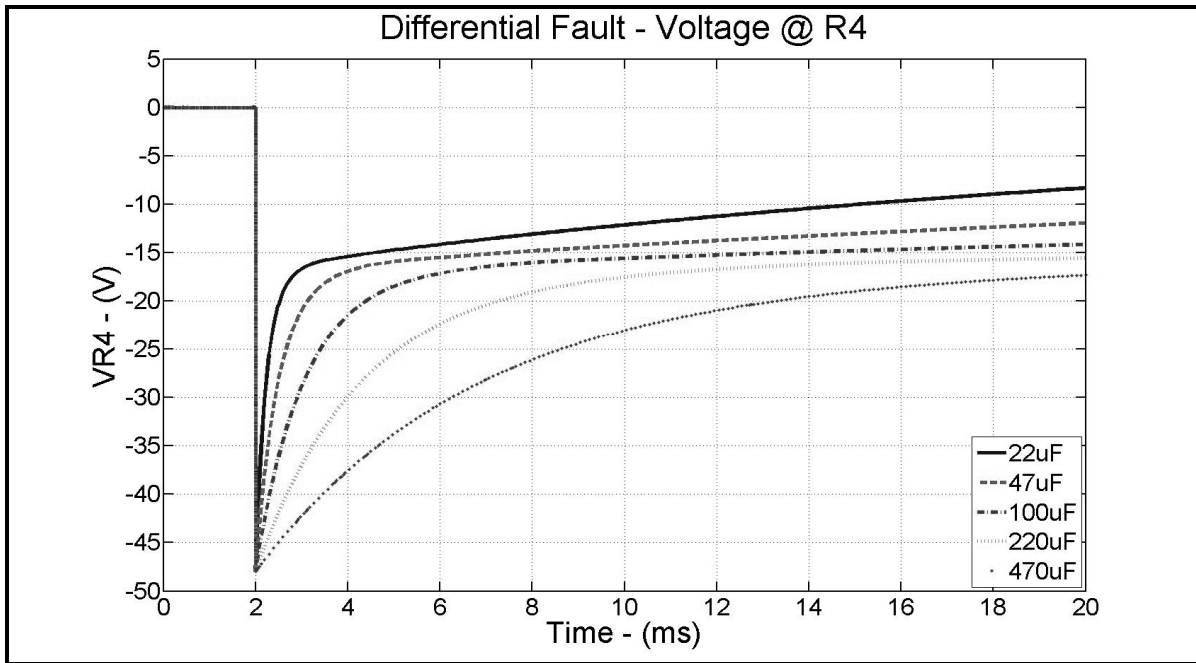
When the differential fault occurs, a -48 V transient appears across bias resistor R4 (Figure 9). Input capacitor C1 supplies high currents (Figure 10) as it discharges. As in the other fault mechanisms, the simulation shows that this current splits in several ways, flowing to the V- rail through a) protection diode D12; b) protection diodes Q3 and D14; c) Q3 in series with RG and D24; d) Q3 in series with RG, input transistor Q2, and protection diode D22; and e) through Q3, RG, Q2, and input capacitor C2. As with the other mechanisms, after the voltage across R4 becomes more positive than the V- supply (assumed here to be -15 V),

Figure 9. Voltage across bias resistor R4.

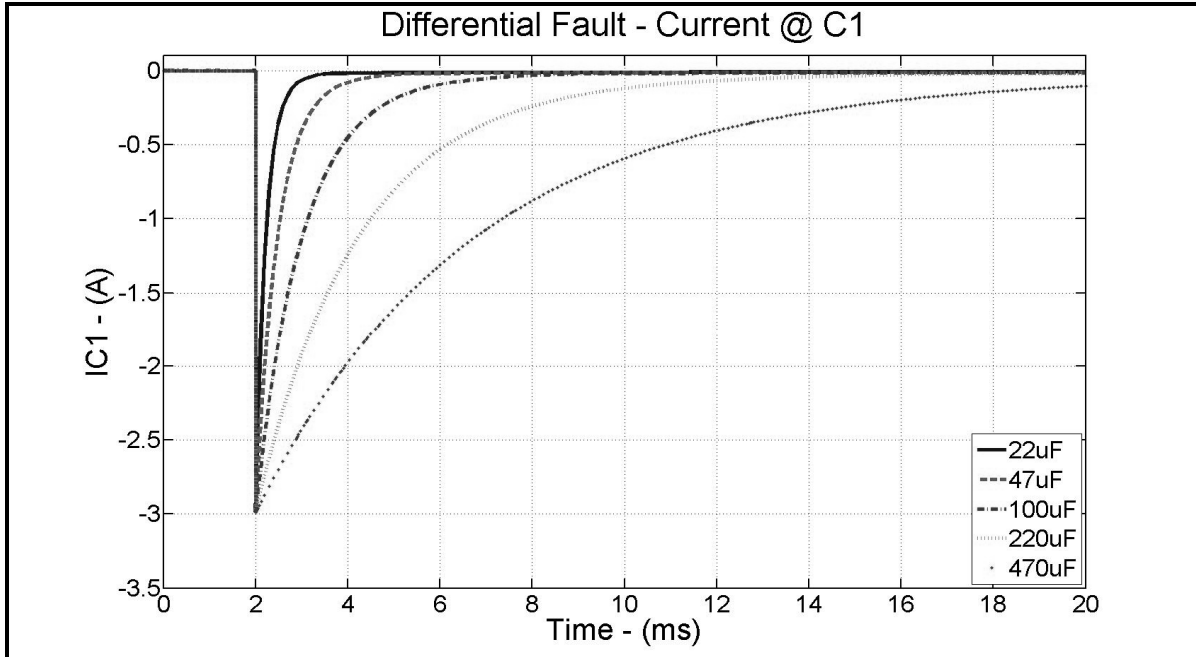
Figure 10. Current through input capacitor C1.

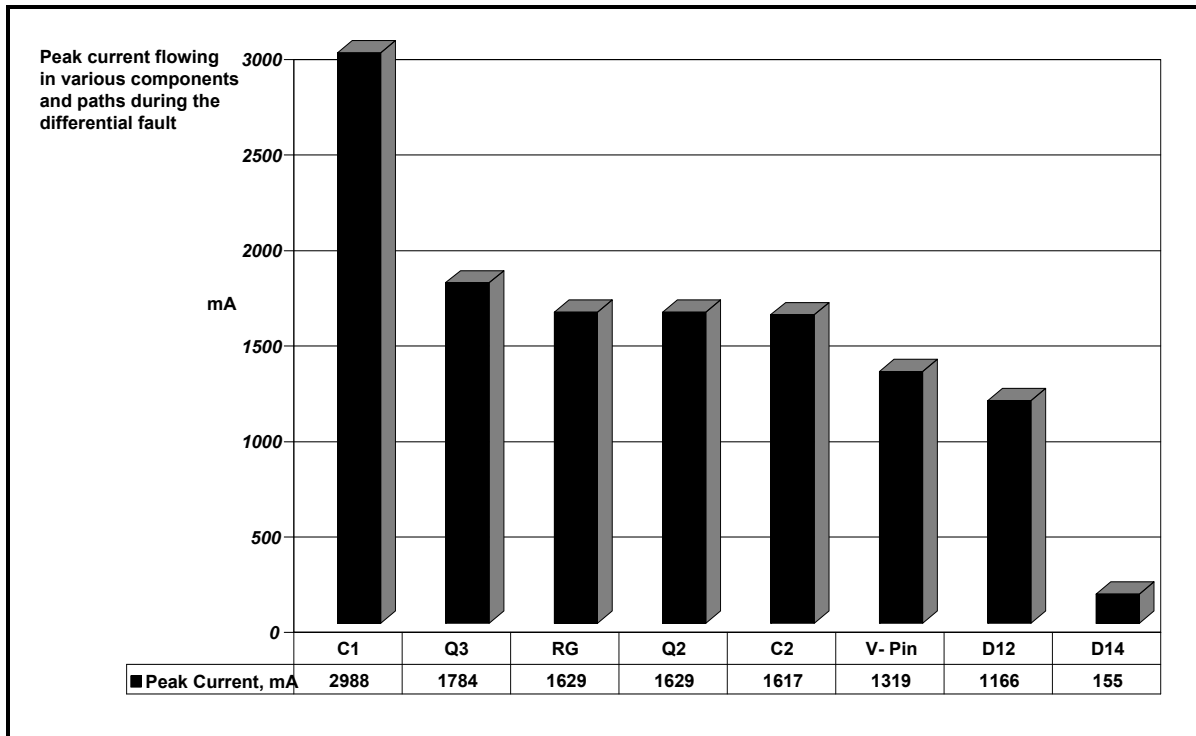
the current through the IC drops to almost nothing, and the remaining charge bleeds off through R4. Figure 11 shows the associated fault currents through these paths.

In the simulation, approximately 40% (a little over 1.1 A) of C1's discharge current flows to the negative supply rail through ESD protection diode D12. The other 60% (almost 1.8 A) flows through reverse Vbe protection diode Q3. Only a small portion of Q3's current flows through ESD protection diode D14; the majority of current flows through gain resistor RG (set to 10 Ω in this simulation). The RG current flows through the base-emitter junction of Q2 and capacitor C2, and then to ground through SW2 (which is permanently closed). No current flows through protection diodes D24 and D22.

Figure 11. Current distribution during the differential fault.

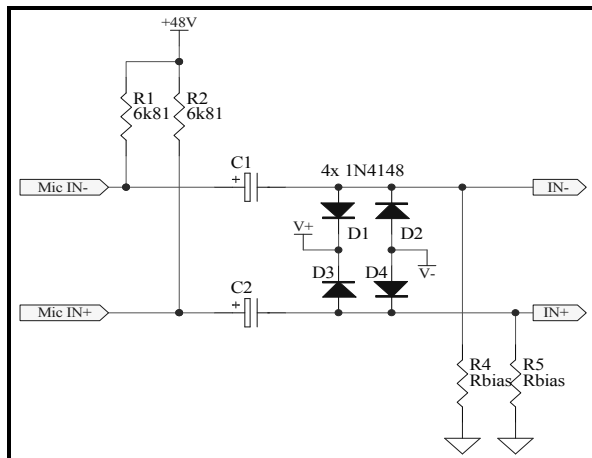
Figure 12 shows a common protection scheme using four 1N4148 diodes in a bridge configuration. This circuit attempts to clamp the input signal to the rail voltages, V+ and V- [3,4]. Unfortunately, these small-signal diodes have too much forward voltage drop at the currents involved to steer enough current away from the IC. Moreover, the bridge concept (even if realized with power diodes) is ineffective against the input loop current generated during a differential fault.

Figure 12. 1N4148 bridge clamping the input signal to the rails. (Not recommended.)

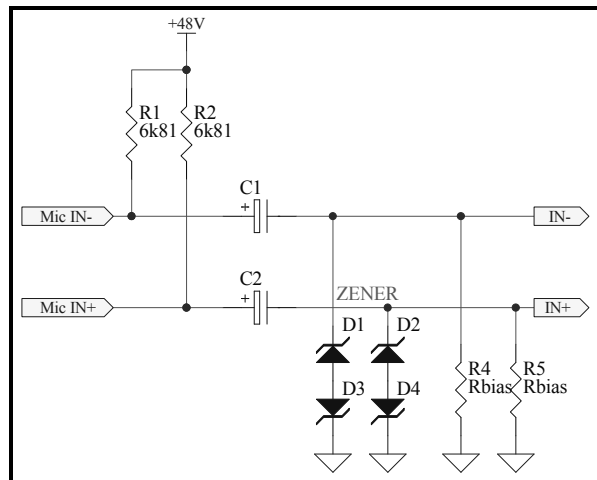
Figure 13 shows a protection scheme using four zener diodes in a paired, back-to-back configuration, which attempts to clamp the input signal relative to ground [5]. In the authors' experience, this configuration will not reliably protect the IC unless the zener diodes are very large. ½-watt and even 1-watt zeners do not survive the high currents (several Amperes) generated by some fault conditions. The situation is exacerbated because the zener diodes have significant voltage across them when they conduct. During the fault, they must dissipate significant power.

Figure 13. Zeners back-to-back clamping the input signal to ground. (Not recommended.)

Moreover, this scheme may give a false impression that it is working because zeners will often fail as a short circuit. A single shorted zener will make the other zener it is connected to appear to the IC input as a diode. When this happens, the preamp may successfully pass low input-level signals, but will distort significantly at high levels.

One other consideration for the zener approach is that it may not offer protection when the unit is powered off. As shown in the simulations, one significant path for current to flow is to the negative rail. If the input is mis-connected to another preamp (powered up with phantom turned on), the zener diodes will only prevent the inputs from seeing signals up to their breakdown voltage. This might be enough to damage an un-powered IC.

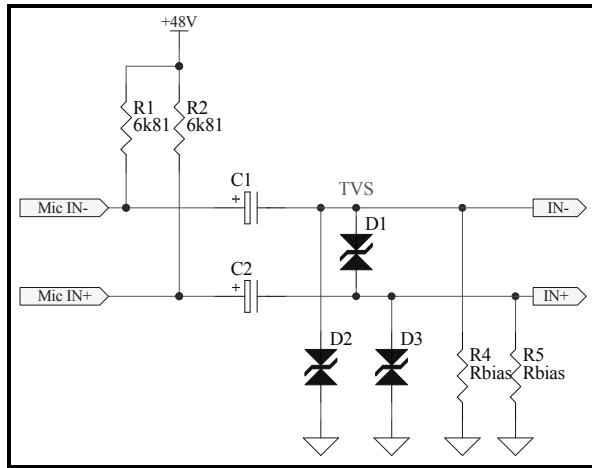
Figure 14 shows a protection scheme using 12-18 V bidirectional Transient Voltage Suppression (TVS) diodes. Because the TVS diodes are more rugged than typical 1/2- and 1-watt zeners, this scheme protects the IC in all three fault modes. However, in the authors' experience, TVS diodes have high intrinsic capacitance and substantial nonlinearities. These can interact with the source impedance to cause significant distortion to the signal. As a result, the authors do not recommend using TVS diodes directly across the preamp inputs for phantom fault protection.

Figure 14. Bidirectional TVS to ground and between the inputs. (Not recommended.)

TVS devices, isolated in this way by their use on the power supply lines for the preamplifier do not contribute signal distortion. This makes them applicable, in contrast to the circuit of Figure 14, which is not recommended. It is also possible to share elements from the circuit of Figure 24 among several preamplifiers, isolating each individual input with its own bridge (and providing each input with individual D5 and D6), but sharing the supply isolation and bypass components. The authors consider this one of many areas for further investigation.

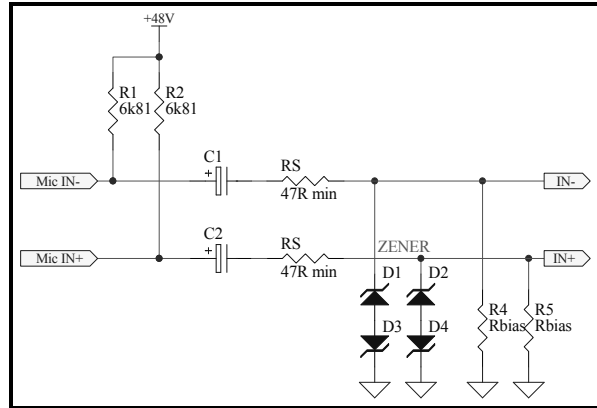
Figure 15 shows a protection scheme using four zener diodes, in back-to-back configuration, with series resistors placed in front of the zeners to limit the fault currents. Jung and Garcia found that the minimum value for the series resistors should be approximately 47 Ω [6]. The resistance limits the current to a low enough value that the zeners survive the fault. However, the additional 94 Ω in series with the source compromises the noise performance of high-performance IC preamps [1].

Figure 15. Zeners back-to-back to ground with series resistors. (Effective protection, but compromises noise.)

A compromise might be sought by reducing the series impedance and increasing the wattage of the zener diodes. However, in the authors' experience, if the zeners are large enough to handle the fault currents, they increase distortion. Of course, if they are too small, they become sacrificial.

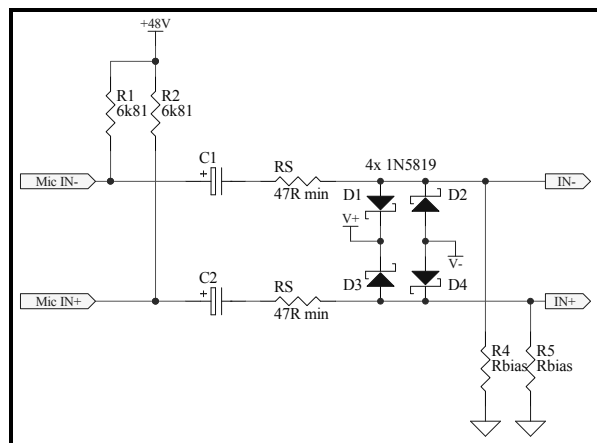
Figure 16 shows a protection scheme that uses Schottky diodes in a bridge configuration, clamping the input signal to the rails, with two resistors placed in front of the bridge to limit the fault current. The authors have found that minimum value of these resistors, required to protect against differential faults, is 47 Ω. Like the circuit of Figure 15, this compromises noise performance [1].

Figure 16. Schottky diode bridge clamping inputs to the rail. (Not recommended.)

Moreover, Schottky diodes used in this way tend to introduce noise and DC offset due to diode leakage. While Hebert/Thomas once recommended this approach, the authors now recommend against it.

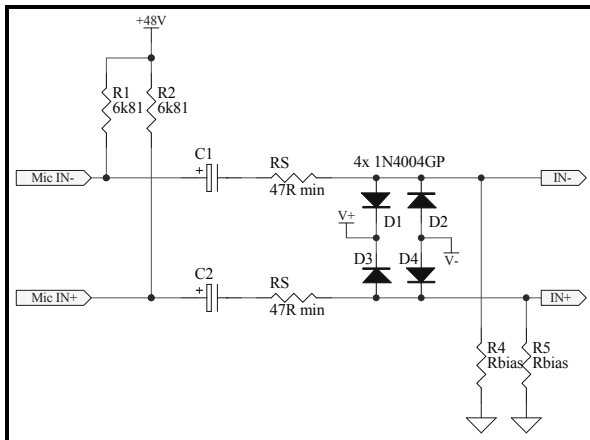
Figure 17 shows a protection scheme using 1N4004GP¹ diodes in a bridge configuration, with series resistors placed in front of the bridge to limit the fault current. This circuit attempts to clamp the input signal to the power rails. The 1N4004 diodes are inexpensive and readily available.

Figure 17. 1N4004GP diode bridge clamping the inputs to the rail, plus input series resistors. (Effective, but compromises noise performance.)

The authors' experience is that this circuit will protect the part against all three fault modes, provided the series resistors are large enough. The 47 Ω resistors shown are effective, but they compromise noise performance at high gains. Previously, THAT Corporation had suggested this scheme in the past, with only 10 Ω series resistors. The authors have found that without more current limiting (extra resistance) this scheme will not protect the IC from differential faults.

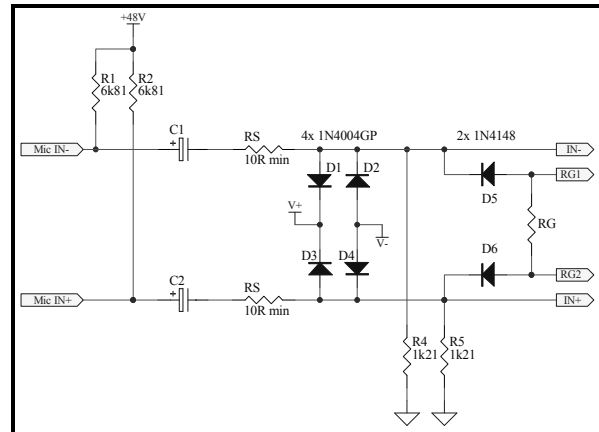
Table 1 reveals that very large currents flow through the input transistors, RG, and internal reverse Vbe diodes, Q3 and Q4 (Figure 2), during differential faults. Differential faults are most destructive to Q3 and Q4. Figure 18 shows a protection scheme which includes a pair of 1N4148 diodes to steer currents around Q3 and Q4 during faults. With the addition of these diodes, the current-limiting resistors at RS may be reduced to 10 Ω

each, so noise performance is not unduly compromised. The authors have found that this protection scheme is effective against all three fault modes, and recommend it in preference to others.

Figure 18. Proposed protection scheme which incorporates two 1N4148 to steer the currents away from the base-emitter protection diodes.

After analyzing the three fault mechanisms, and considering the various protection schemes presented above, the authors focused on the circuit shown in Figure 18. This circuit was tested with a variety of microphone preamplifier ICs [2-6], and found to be both robust in protecting the ICs and ‘transparent’ in audio performance.

Given that the SPICE simulations presented above do not represent the real world of regulated power supply behavior, the authors measured the recommended circuit shown in Figure 18 on the bench. The results presented earlier show that the differential fault is the worst-case scenario, so the authors concentrated on that one. As well, the current flowing through the IC's front-end stage is essentially equal to the current flowing through the gain resistor R_G and the internal base-emitter protection diodes. Thus, the differential voltage across R_G permits indirect measurement of internal junction currents. Limiting transient currents through these junctions is the key to protecting against differential faults.

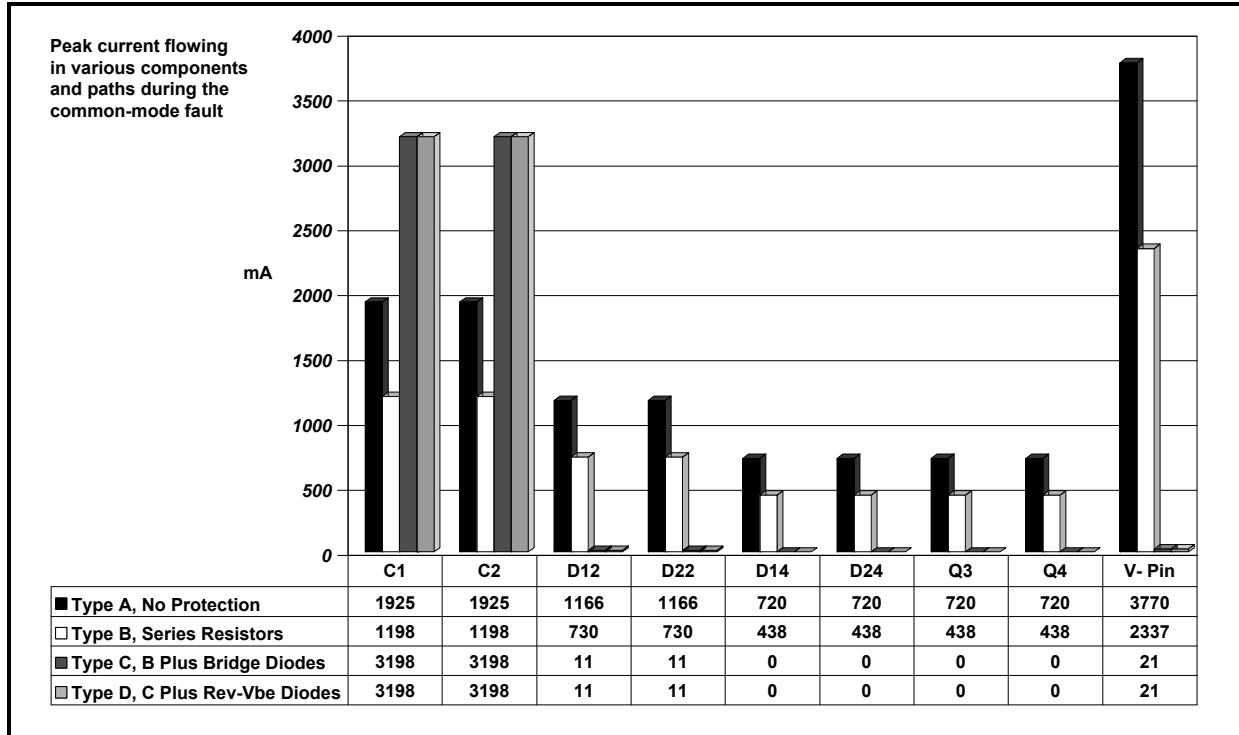
To understand why this circuit worked so well, the authors ran simulations of all three fault modes with different elements of the protection scheme shown in Figure 18. The results are shown in Figures 19, 20, and 21.

Figure 19. Current distribution during the common mode fault for the circuits type A, B, C, and D.

The addition of 10 Ω input series resistors reduces fault currents, but 20 Ω (total) is not sufficient to protect the IC from differential faults. The experiments suggest that all preamplifier ICs will fail without some input series resistance. As well, although beyond the scope of this paper, the authors suspect that discrete designs will be similarly challenged by differential faults.

Adding the diode bridge to the rails appears (in the simulations) to provide signal clamping and current steering, but it also increases the fault current. The bridge steers voltages and currents away from the IC (and into the “stiff” negative supply rail) by reducing the impedance seen by the input capacitors while it clamps. This is why the discharge current is larger. However, by steering currents away from the IC, the diode bridge also significantly reduces the damaging currents flowing in the IC.

The external base-emitter diodes D5 and D6 are in parallel with internal diodes Q3 and Q4. They serve to reduce the current flowing in the internal protection diodes. D5 and D6 allow the input series resistors to be reduced from 47 Ω to 10 Ω while still protecting the part. This is important to maintaining a low noise floor.

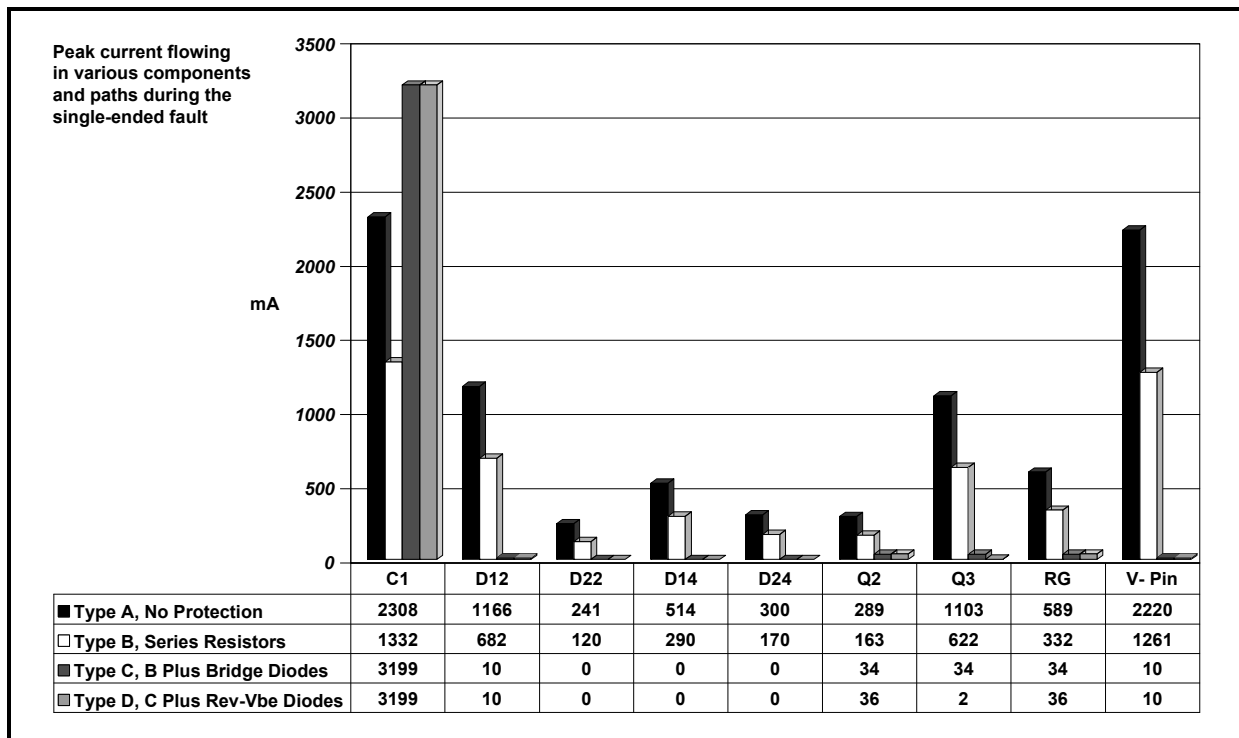
Figure 20. Current distribution during the single-ended fault for the circuits type A, B, C, and D.

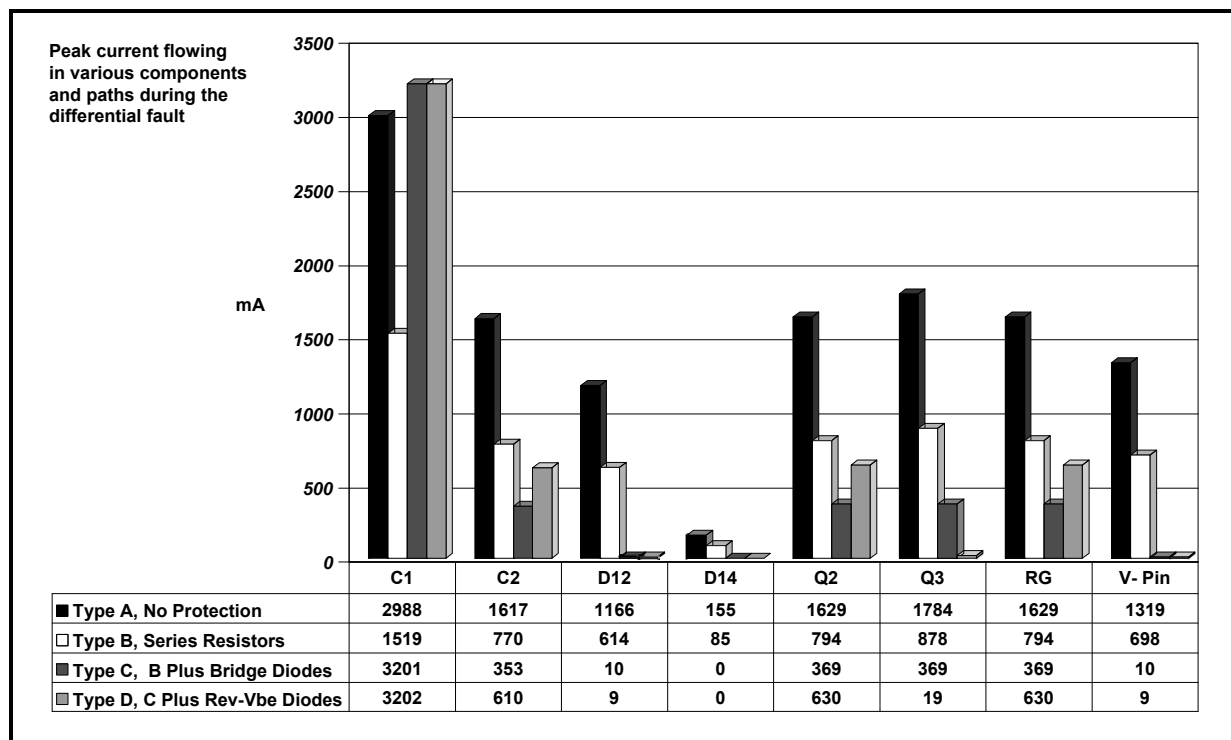
Figure 21. Current distribution during the differential fault for the circuits type A, B, C, and D.

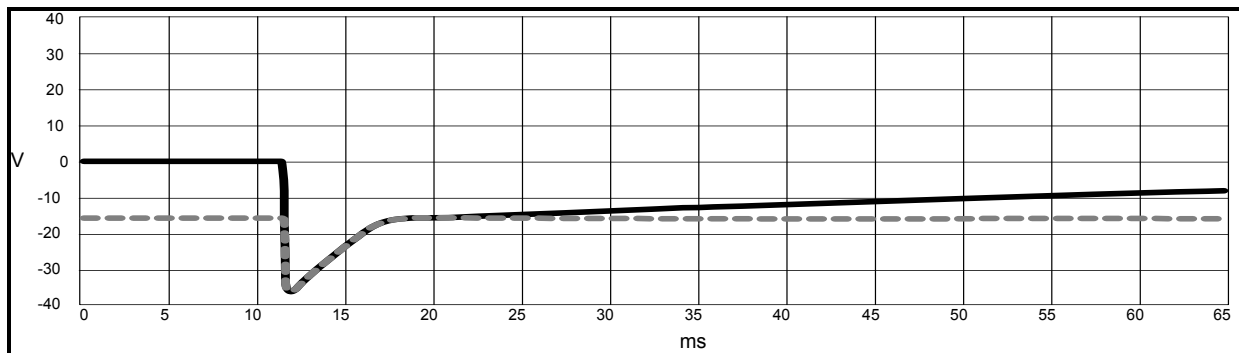
Figure 22. During the fault, in the circuit of Figure 21, the negative rail (dashed) follows the voltage across R_4 (solid).

Initially it was suspected that the voltage to which the supply is driven would depend on the capacitance on the negative supply. But, after some investigation, the authors observed that the circuit was clamping to the bench power supply's regulator input voltage, which has a much larger filter capacitance than its output.

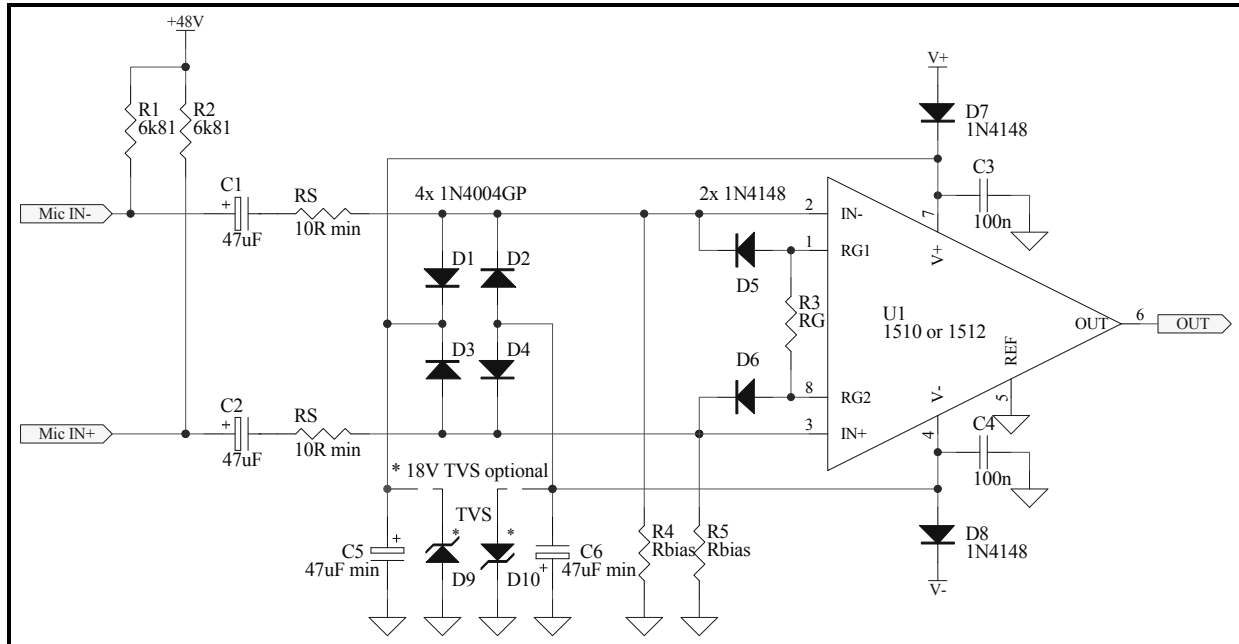
In Figure 24, diodes D7 and D8 isolate the IC's V+ and V- pins from the power supply rails supplying the rest of the system. D7 and D8 are forward biased during normal operation, but reversed biased when a phantom power fault occurs or an external voltage source is applied to the preamplifier inputs (+48 V discharging from the output capacitors of an ac-coupled line output previously connected to a phantom power source, for example). The protection bridge (D1~D4) terminates on the IC side of the supply diodes D7 and D8, containing any overvoltage from faults to within the preamp system itself. A modest-sized bypass capacitor (C5 and C6, shown as 47 μ F) serves to absorb some of the charge during the fault, limiting the voltage excursion at the supply pins.

Figure 24. New protection scheme with diode-isolated rails (D7, D8) and bypass capacitors (C5, C6) to ground.

It was found that bypass capacitor values should be at least equal to the value of C_{in} ($C1$ or $C2$, Figure 24), and ideally greater than two times C_{in} , to provide protection from common mode faults where the effective value of C_{in} is doubled.

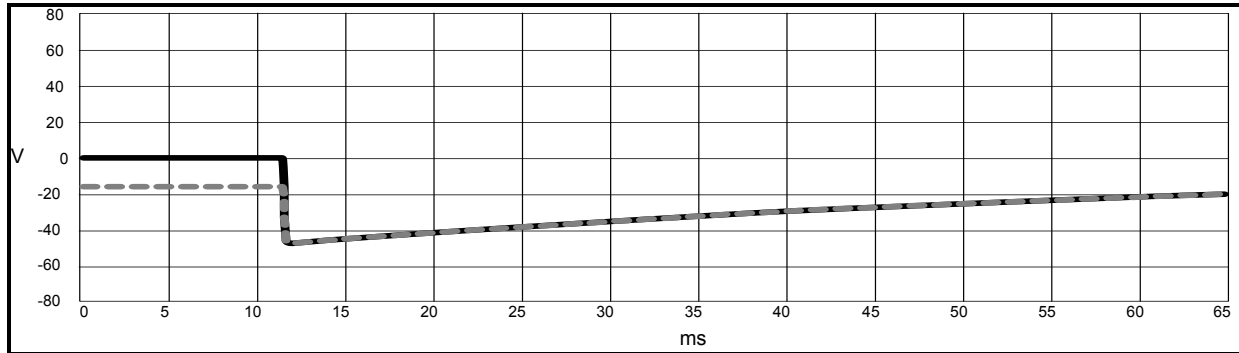
Figure 25 shows the IC input voltage at Rbias (solid trace) and the isolated V- pin voltage (dashed trace), with capacitor C6 = 0.1 μ F, during a phantom power fault on the Mic IN+. The voltage at the IC's IN+ pin drops to approximately -48V. Without a means to absorb the input capacitor's charge, V- tracks the input voltage. Figure 26 shows the voltage at IN+ and V- for C6 = 47 μ F. Note, of course, that if C1 and C2 are scaled, the transient peak will scale directly unless C6 is also scaled similarly. Partly for this reason, and considering low-frequency response versus typical preamplifier input impedances,

Figure 25. Isolation diodes without capacitors C5 and C6. Input voltage (solid) and isolated negative rail (dashed).

the authors recommend that the input coupling capacitors be no larger than 100 μ F. As shown in Figure 25, unless a sufficiently large bypass capacitor is used, during fault events the negative rail can be driven above the maximum rating for typical IC preamplifiers. While the authors' experience is that IC preamps seem to survive this abuse, this does raise concerns over reliability. One way to address this without requiring such large capacitance is to place a TVS diode across the rail as shown at D10 in Figure 24. Figure 27 shows the same voltages if an 18 V TVS is included at D10.

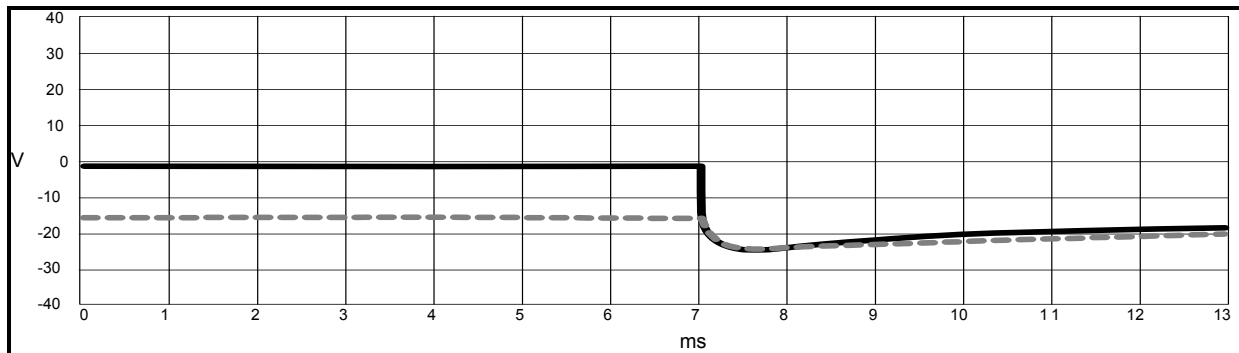
Figure 26. Voltage at IN+ (solid) and V- (dashed), for the circuit of Figure 24 as is.

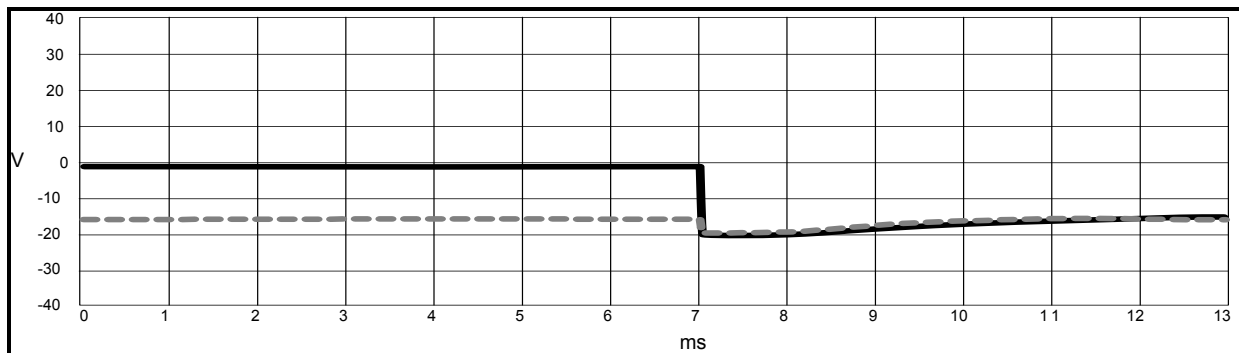
Figure 27. Voltage at IN+ (solid) and V- (dashed), for the circuit of Figure 24 including 18 V TVS diode at D10; C6 = 47 μ F.
