Convention Paper 7909

The 48 Volt Phantom Menace Returns

Rosalfonso Bortoni¹ and Wayne Kirkwood²

THAT Corporation, Milford, MA, 01757, USA
rb@thatcorp.com and wek@thatcorp.com

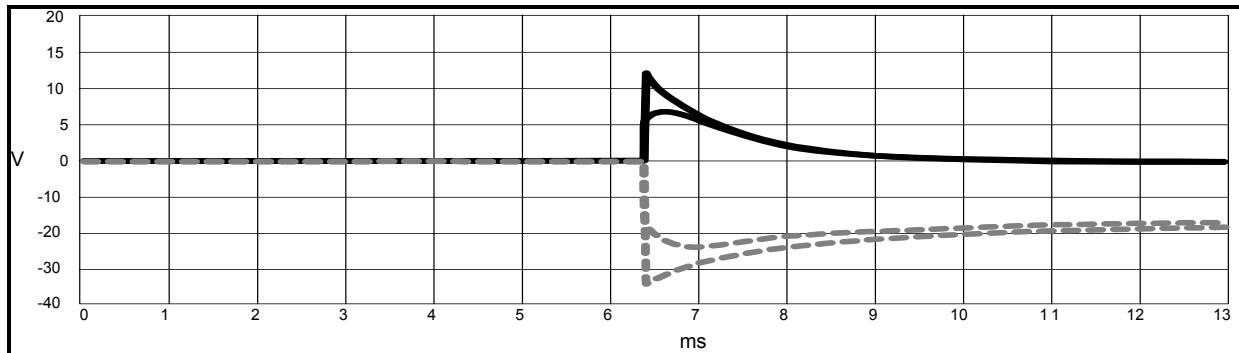
Figure 28 shows the voltages across the $10\ \Omega$ gain resistor (solid traces) and the isolated V- pin (dashed traces) using $0.1\ \mu\text{F}$ and $47\ \mu\text{F}$ bypass capacitors at C6. With a $0.1\ \mu\text{F}$ bypass capacitor, the peak current flowing through RG is approximately 1.2 A. With a $47\ \mu\text{F}$ bypass capacitor, the RG current drops significantly to approximately 700 mA. This current can be reduced even further if larger capacitors and/or TVS are used. The use of bridge diodes, TVS devices, and capacitors, has been explored by others to protect sensitive low-voltage programmable gain amplifiers against phantom faults [7].

Figure 28. Differential fault. Voltages across the gain resistor (solid) and the isolated V- voltages (dashed), for $0.1\ \mu\text{F}$ and $47\ \mu\text{F}$ bypass capacitors.
